## METHOD TO ANALYSE THE FAILURE PROCESS OF METAL-POLYMER IMPLANTS BY 3D SCANNING

### Abstract

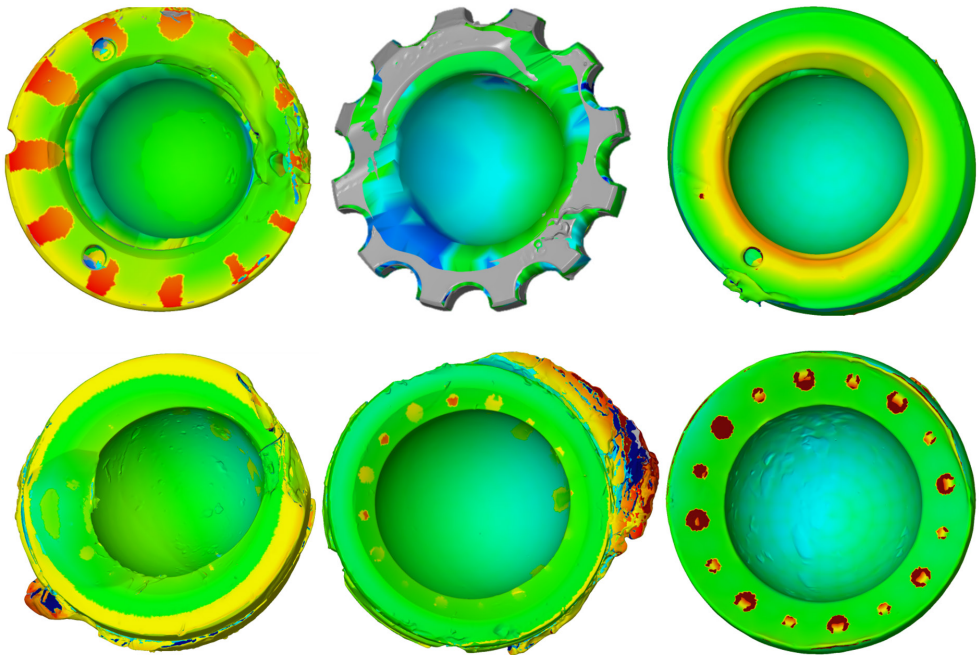
In the case of implants without cement fixation – Figure 5 top line – it can be noted that the first and third samples are of an older type, but the middle one is a modern prosthesis.

The first implant can be said to have worn along a band during wear, so a stripe can be seen in the images. The spherical part of the cup, which came into contact with the head, became ellipsoidal, the major axis of which is the previously mentioned band. Point corrosion, scratches, and abrasions can be observed

on the surface. The edges of the right-hand cup were wrinkled – also along a band – due to deformations. Abrasions and scratches could also be observed on its surface. However, these changes are perhaps not as conspicuous as the change in the middle workpiece, which is strange since it seemed the youngest of the three prostheses based on its design.

In the case of cement-fixed implants – *Figure 5* lower line – the difficult-to-remove bone cement caused some problems during the meas-

*Figure 5.* Scanned hip joint implant sockets (upper row – cementless, lower row – cemented sockets)

In the figures, the elliptical shape of the spherical part of the tufts can be observed with a simple eye measure without taking colouring into account. It was also visible that the rate of uneven wear was also much higher than that of their cementless counterparts.

Also, with these implants, it can be seen that there is a privileged direction in which the head begins to wear out the cup. In the first two cases this is well visible but even in the third, it can be seen, although it presumably spent a much shorter time in regular use. This can be explained by the fact that the material loss found on it is much less than that of other cement-fixed ones. Still, on its surface, a significant amount of craters, abrasive debris, and abrasions can be observed in the pitting pattern. At the same time, relatively large pieces also detached from the cup, leading to implant loosening and premature revision.

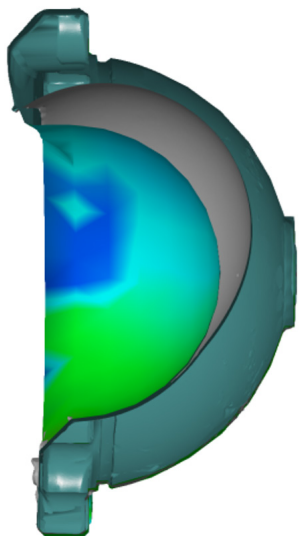
The middle (upper) sample shows that the head began to deepen the ravine around a point, and this process was already very advanced (*Figure 6*). On the opposite side, however, the material was practically not consumed, so there was no stress on the part at that location. At this certain critical point the material thinned so much that, if the implant was kept in intense light, it was almost transparent. The shadows on the other side were already visible, so this clearly had to be replaced during revision surgery.

ous than that of the other two implants, as here the loads and abrasive effects are concentrated at and around the critical point, but the only abrasion was observed on the work surface.

The approximate original wall thickness is shown at the below part of the cross-sectional figure in *Figure 6*, where the point cloud and the geometry of the CAD model are presented together in overlay. On the other hand, as we look upwards, these two surfaces become more and more distant from each other. The change can also be traced in the colouring, the almost perfect fit is green, while in the upper section, it is getting darker blue with a marked dark blue spot between the blue and green gradients, probably representing damage created during resection.

Figure 6. Cross-sectional 3D scan view of the second investigated cementless (Figure 5 upper row, middle) hip joint socket

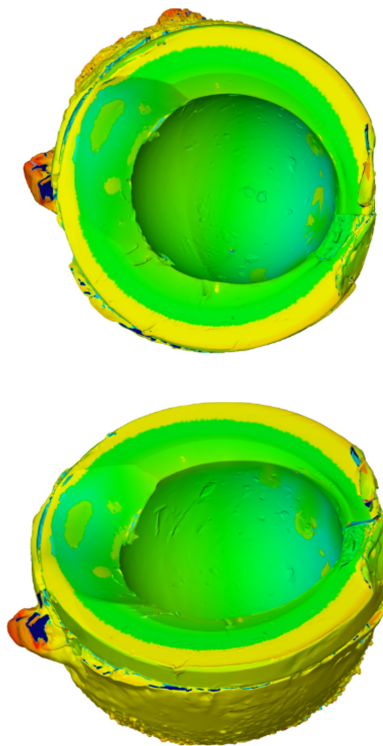
Similar surface damage was observed on the first implant, but there the surgeon performing the primary operation fixed the prosthesis into the pelvis in the wrong position, so the femoral neck of the prosthesis touched the cup, creating a depression on the left side of the part of the implant. Damage to this prosthesis (Figure 7) suggests that this may have inhibited the patient's movement, as otherwise, such damage on the cup would not have occurred. This could have caused several problems and symptoms while wearing it.

Implantation of the second prosthesis was appropriate. Even so, its distortion is comparable to that of the first. The recess on the right side is also shown to be blue on the colour scale (Figure 7), and it can be seen with the naked

Figure 7. 3D scan of an incorrectly implanted socket

eye that its shape has changed to an oval shape during use. On the other hand, the inner surface of this - in contact with the head of an artificial joint - is relatively even. There are no grooves, scratches, or other signs of damage.

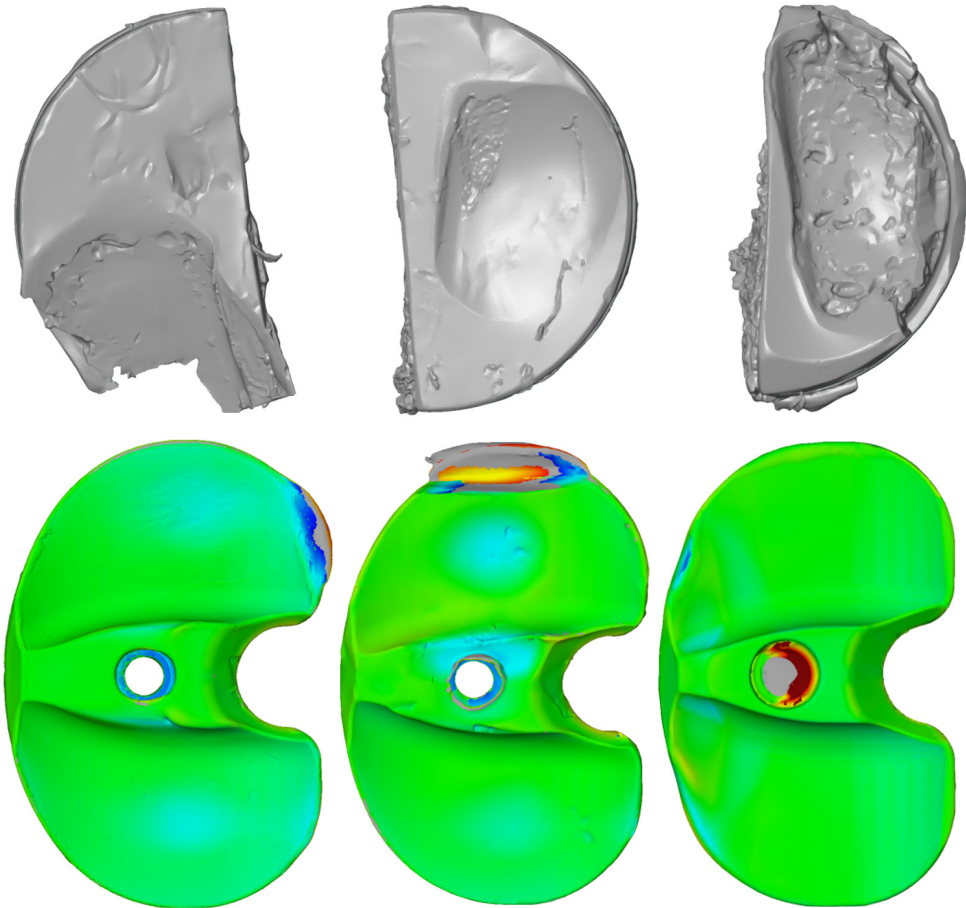
In the case of knee implants, we examined 3 unicondylar knee implants – *Figure 8* upper row – the first two without cement and the last with cement fixation. With these implants, only one condyle of the knee is removed. During the measurements, we did not have a CAD model of the workpieces, and, considering the severe damage, we could not fit a structure that adequately represented the original ge-

ometry to the point clouds, but the extent of the damage is still obvious. It can be said that practically all 7 forms of damage can be found on all uni knee implants, so it does not make sense to highlight them separately. It can be seen that the artificial heads did not wear their surfaces parallel to their longitudinal axis and often not in the middle, so their positioning was not correct. It is due to this, and probably their asymmetrical design – as well as their small tread area – that they received such high forces and abrasive stresses locally that all of them required immediate revision surgery due to an accident-like, sudden failure.

*Figure 8.* 3D scans of total knee replacement implants

Looking more closely at the first implant, it can be said that the lower corner was practically completely perforated, the artificial head was already working on the metal basket of the cup. This may be one of the interpretations because metal shards were practically rolled into the UHMWPE in the damaged zone. A further interpretation for this is that the metal fibre used for the marker, which can be used to tell how much the implant is worn *in vivo* on X-rays, has wholly disappeared near the cavity.

Examining the second prosthesis, it can be declared that it suffered the least damage and the operation was the best performed, but at the same time, extensive damage and severe locally concentrated lesions can be observed.

Taking the third implant under examination, it can be said that the material detachment was already extremely increased here – huge craters on the tread surface – and grandiose pieces were torn off the corner of the cup. This can be observed between 1 and 5 o'clock since the lower side of the groove containing the

marker thread has already become free – the upper side has disappeared – fortunately, the metal thread has not been damaged. Here too, it can be said that the damage was already in the phase of sudden destruction and due to the large detached pieces, this was probably the greatest danger to the patient.

Examining total knee implants, it can be said that they suffered significantly less damage than the sledge prostheses. In terms of their fixation, all were cement-free.

The most seamless was the third cup, with some abrasions and polishes on the back, running all the way to the middle tract, where scratches can be observed. Deformation is still visible in the posterior and central areas, but the extent of this is not significant either. The almost novel condition of the examined sample suggests that it was most likely removed due to infection or loosening.

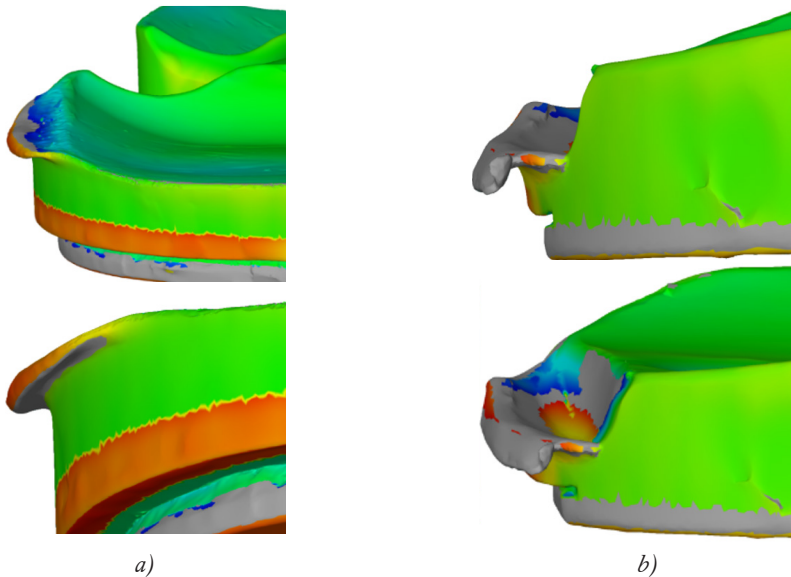
Examining the first prosthesis, the middle and back sections were damaged and, not signifi-

Figure 9. Investigated right back edge of the first investigated sample  
 a) left edge of the second investigated sample; b) tie-shaped deformation

cantly, obliquely, with scratches and abrasions, and a phenomenon known in the literature as a bow tie, a bow-tie sign (*Figure 9*).

This can also be observed on the right side of the middle sample. However, two recesses can be seen in the central area of the implant – with pitting, abrasion, and scratches around them – it does not appear so markedly here that the wear in the posterior regions is almost the same as in the middle. It can be said that the structure operated at least one-sided, as the deformation on the right side is more extensive, but this is not as significant as in the case of uni knee implants.
