Conservarea și restaurarea clădirilor istorice din Piața Unirii din Timișoara

EXEMPLE DIN PRACTICA PROFESIONALĂ

The Preservation and Conservation of Historical Buildings in Unirii Square, Timișoara

PROFESSIONAL PRACTICE EXAMPLES

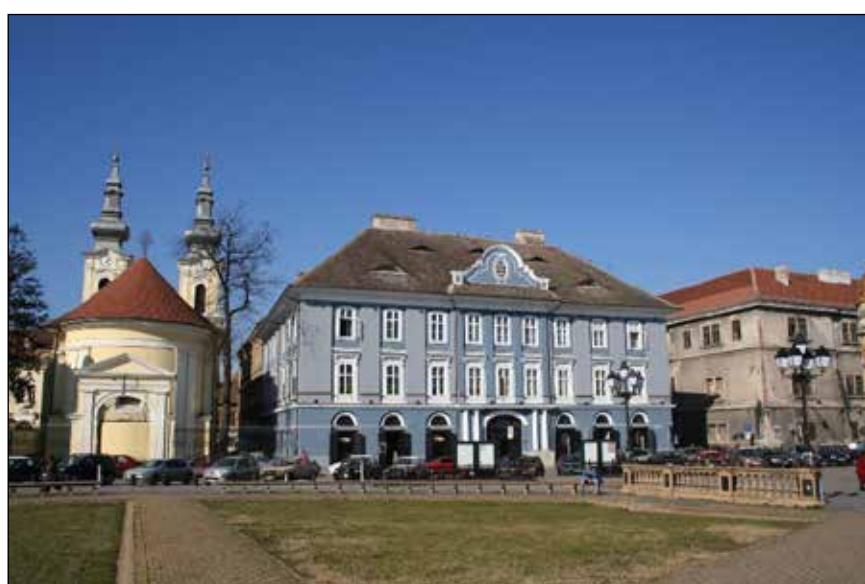
■ Foto 1. Imobilul din Piața Unirii nr. 5 © Bogdan DEMETRESCU

■ Photo 1. The building at 5 Unirii Square © Bogdan DEMETRESCU

The basements were closed, even blocked, with moisture issues caused by leakages from the water network penetrating the masonry load-bearing structures or by uncontrolled leakages of the rain- and groundwater collection systems, and by an old sewage system in the infrastructure of the bastion, out of service and fragmented by the systematisation works mentioned above. The useful area of the basement under study was of 180 m² during the first stage of the works and reached approximately 400 m² in 2007, which is more than 60% of the building's built area. The structure consists of brick foundations, with type 8 period brick masonry (Ghid privind intervenții...) used for the upright walls, the arches, and the vaults.

dialogue between the old and the new, which can be found at the level of materiality, texture, light, or even structure, as it is an example of sincerity in the transformation of a forgotten place. The volume of the brick masonry structural system becomes the sombre background of a minimalist scenery, where the foundation's consolidation works are brought to light through glass flooring, the new partitions are made of raw concrete diaphragms, and the metal surpasses the austerity of concealed lintels, becoming a portal that articulates different textures. This is completed by the layer of leather that elegantly covers the metal furniture placed on a concrete plate that seems to be suspended and articulated in relation to the old masonry. This design was a first exercise for understanding the elegance of a masonry structure, thus removing the sombreness of an austere structural scheme by searching for new aesthetic relationships between materials that apparently only preserve the hidden role of consolidations. In the case of these interventions, major differences were found between the geotechnical investigation and the situation on the field, where the groundwater had slightly different benchmarks within the perimeter of the same space. In addition to the interior design works, a strategy for the permanent ventilation of the basement was put in place. It consisted in reopening the ventilation openings that had been closed off, in adding mechanised ventilation, as well as in paying attention to the water movement in the brick masonry, no matter from what direction it came. In this sense, the floorings with screed finishes do not enter in contact with the old masonry, which results in a detail highlighting the balanced relationship between the historical and the contemporary. 90% of the old masonry was left visible. Attention was paid to the grouts and to the treatment for enhancing the texture and the chromatics.

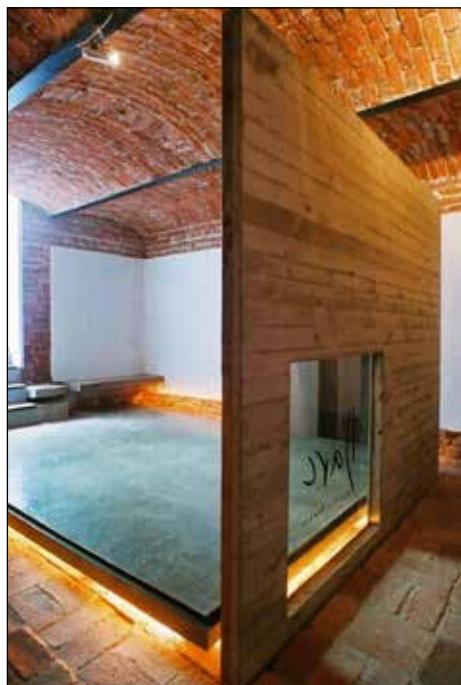
Foto 2. Aparatul de acces la amenajarea subsolului, imobilul din Piața Unirii nr. 5
© Bogdan DEMETRESCU

Photo 2. Access to the refurbished basement, building at 5 Unirii Square © Bogdan DEMETRESCU

The beneficiary wished to transform the basement into a commercial area intended for a wine&coffee bar. This involved changes and the adaptation of the area to the standards specific for this type of function. The intervention was an example of good practice at that time, and it strengthened the urban regeneration strategy of the local administration in that period. The design was based on the conclusions of the technical assessment (TUDOR 2001) and sought to develop a theoretical discourse adapted to the conversion of residual spaces in buildings with heritage value, proposing the interpretation of an architecture that is open to the balance between memory and progress. The interior design work stands out by a permanent

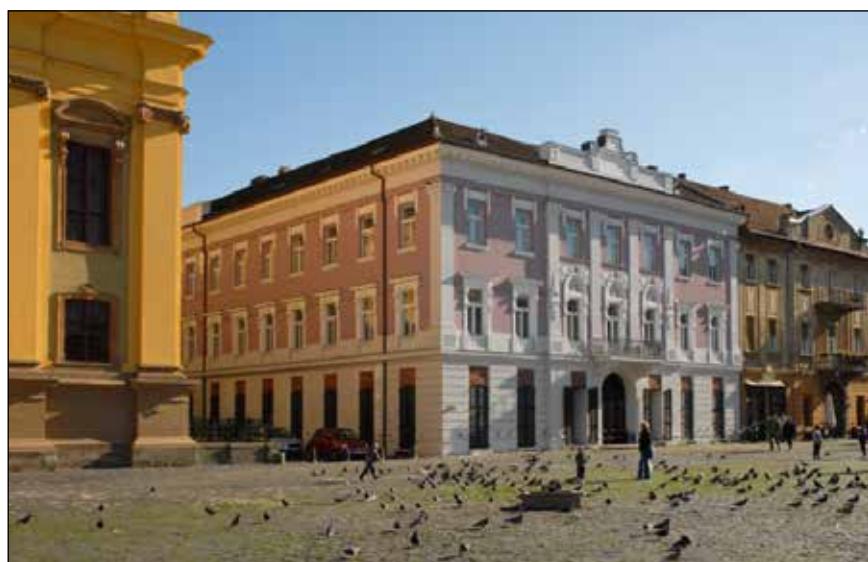
■ Foto 3. Piața Unirii nr. 13 – fațada principală © Bogdan DEMETRESCU
■ Photo 3. 13 Unirii Square – main elevation © Bogdan DEMETRESCU

The building lies on the eastern side of Unirii Square. It occupies a rectangular corner plot with sides of 24 and 32 m. Its ground plan was developed in several stages. The building is organised around an inner courtyard connected to the square through an access archway. Its constructive system is made up of brick masonry foundations, a structure of brick vaults and arches, wooden slabs at the upper storeys, and a wooden roof structure with ceramic tile covering. The design for this building started in 2009. The first technical reports were drawn up together with a multidisciplinary team, including engineer Petru RUS, PhD (2011) and biologist Livia BUCSA, PhD. These reports revealed structural issues caused first of all by the alterations to the ground plan made during the nationalisation when, due to the transformation of the building into a collective housing, a repartitioning was performed leading to the destabilisation of the initial structural scheme. The ground floor was altered radically because of the new functions, where the wish to have areas with wide openings triggered the forced transformation of a load-bearing structure made of brick masonry walls with vaults and arches into a frame structure with concrete pillars, diaphragms, and opening widenings in the preserved masonry. These structural issues were accompanied by issues related to the groundwater, which had different benchmarks in different probing points in the basement, with different evolutions from one season to the other. The long lapse of time between the preliminary and the detailed design stages allowed us to carefully observe the movement of the groundwater with the help of several geotechnical investigations conducted by engineer Dorin VASIU. The building had lost a large part of its historical materiality, which could be found only at the level of the stone galleries in the courtyard.

The groundwater was a special concern in the architectural and structural proposal. Therefore, a natural ventilation system was put in place for the masonry in the basement. Moreover, in addition to the consolidation works on the foundations, as well as the injection and vertical waterproofing solutions for the walls, a plastic formwork allowing for the ventilation of the space beneath the basement plate was inserted, with connection to the ventilation openings towards the street.

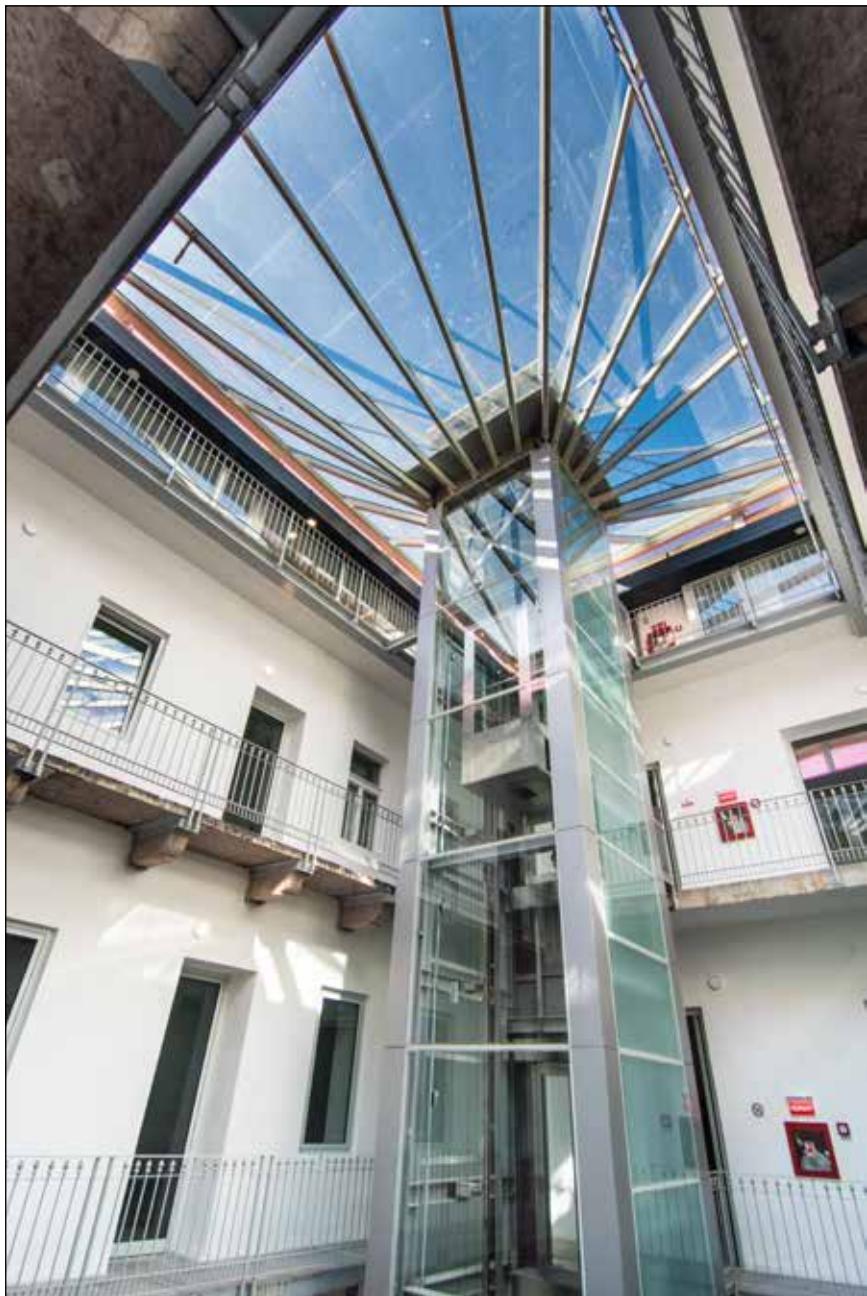
- **Foto 4.** Imagine cu amenajarea curții interioare a imobilului din Piața Unirii nr. 13
© Bogdan DEMETRESCU
- **Photo 4.** Photograph showing the transformed inner courtyard of the building at 13 Unirii Square
© Bogdan DEMETRESCU

attic into a loft facing the inner courtyard. The aforementioned courtyard acquired a different role in the new layout proposed, becoming a transition area from the public square to the interior arrangements, as it was covered and provided with perimetral ventilation, as well as with a panoramic lift that became the support of the glass skylight structure. The latter partially rests on the outline of the metal roof structure that takes over the loads of the historical one, which thus becomes the support of the scenery for the interior design proposed in the loft. The structure's consolidation works were extremely extensive and covered all the components of the structural system, from underpinnings at the foundations, repair or reconstruction works on walls, vaults, or arches, to consolidations or reconstructions of slabs and new metal structures taking over the loads of the historic roof structure.

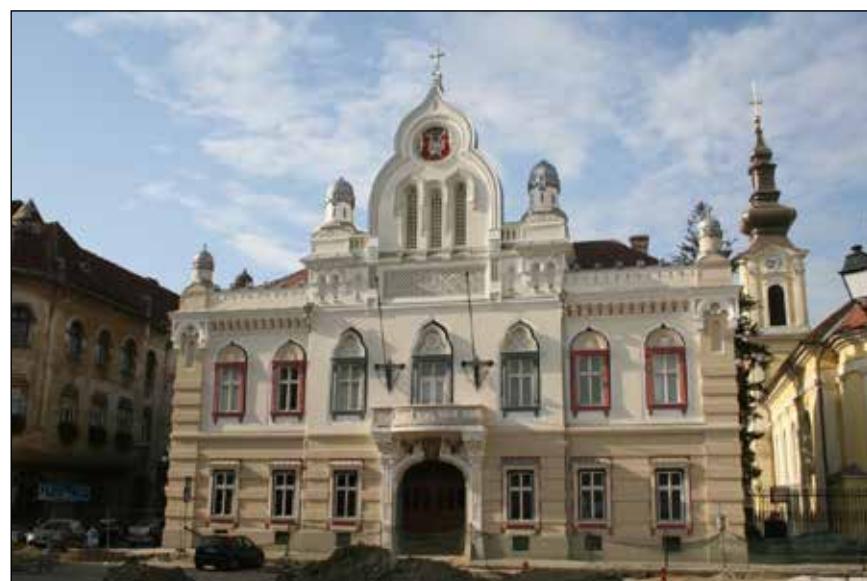
■ Foto 5. Palatul Episcopiei Ortodoxe Sârbe, Piața Unirii © Bogdan DEMETRESCU

■ Photo 5. Serbian Orthodox Bishop's Palace, Unirii Square © Bogdan DEMETRESCU

The building is part of an urban ensemble of rectangular shape on the ground plan, with a side courtyard accessible through an archway with a monumental gate on the main elevation facing Unirii Square. The ground plan and the volume of the building are specific of the Baroque buildings in 18th century Timișoara, with a load-bearing structure made up of foundations in period brick masonry, which we can also find at the walls and vaults for the basement and the ground floor. The slabs above the upper storey are made up of massive wooden elements on which lies a historic roof structure made up of Eclectic trusses built at the beginning of the 20th century. In 2009, the Serbian Bishopric in Timișoara asked for a design aimed at recoating the finishes on the elevations of the Palace, i.e. of the existing paintings. Based on the authorised design, the implementation works started in 2011. The interventions on the elevation through the recoating of the finishes and of the ornaments were the occasion for a closer examination of the cracks that seemed to be the cause of the plaster ageing and of the support layer's inconsistency. The partial removal of the plaster on a certain area has revealed deep fissures and cracks in the elevation wall at the base of the tower flanking the central gable. The close examination of the cornice has revealed displacements of certain roof structure elements as a result of the intervention conducted in 1905. The works on the building elevations carried out in the 1980s, during the rehabilitation of the entire Unirii Square

The constructive solution proposed is based on the technical assessment report (IANCA 2011). Its conclusion was that the deformation of the attic slab was caused by the large weight of the central gable's left side tower, found on the main elevation of the Bishop's Palace, cumulated with the additional loads in the roof conveyed through the support system made up of two rigid metal beams resting on a masonry that directly unloaded on the beams of the attic slab. The deformation occurred as a result of high moisture content in the area of the gable, which has led to the decay of the wooden beam ends of the attic slab. The structural solution for the roof structure at that time is to be noticed. The structural system used was made up of a massive masonry tower that unloaded considerable force through metal elements on the attic slab made up of wooden beams. Moreover, the intervention works at the building's basement and the lowering of the walking level have worsened the foundation issues and led to fissures crossing the main elevation's entire height. The structural consolidation solution for the elevation and the intervention solution for its adjacent elements propose re-establishing the initial building safety level, considering the historical significance and the conservation principles for heritage buildings. The intervention proposed has both an architectural and a structural component, without altering the volume and the ornaments of the elevations.

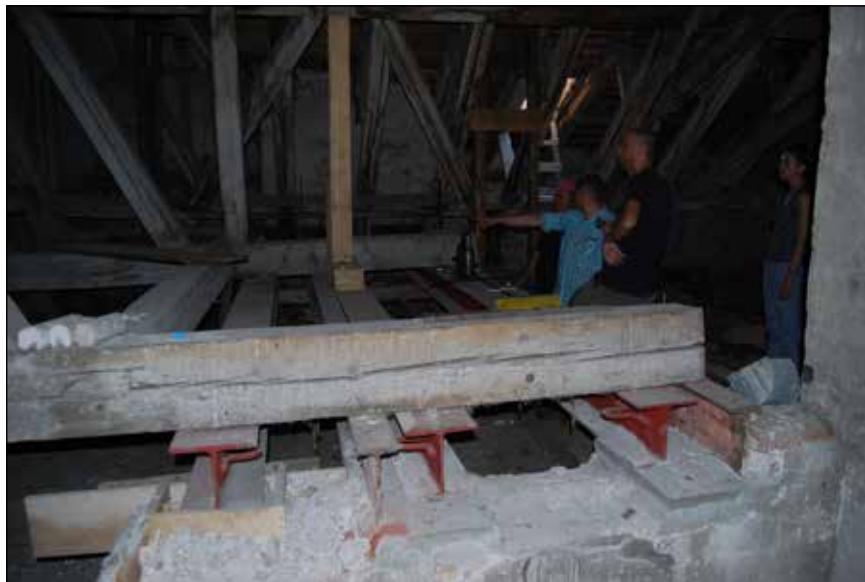
Foto 6. Intervenții de consolidare a șarpantei istorice © Bogdan DEMETRESCU
Photo 6. Consolidation interventions on the historic roof structure © Bogdan DEMETRESCU

The consolidation solution for the roof structure is in line with the type of intervention proposed by architect László SZÉKELY in 1905, when, upon the construction of the central gable and of the towers that were to redefine the style of the whole building, metal elements were used to take over the loads of the roof structure and of the towers. All the proposed intervention does is to double the existing metal beams, which are to take over the entire load of the tower and to unload it this time on the exterior and middle walls, which are

part of the building's structural system. In addition, all the elements of the deteriorated roof structure, as well as the damaged wooden beams that were part of the attic slab were replaced. This made it possible to intervene at the level of the upper storey, where the Museum of the Serbian Orthodox Bishopric in Timișoara was installed. It is to be mentioned that the interventions conducted so far need to be supplemented with works on the foundations of the building and with careful waterproofing against rain- or groundwater. The implementation works are under way, but they are limited in dynamics because of the fluctuating funds coming from the central administration, which has triggered the prioritisation of the works that are to be carried out in stages. The elevation conservation works are not sufficient to consider the building structurally stable. Consequently, priority should be given in the next period to the basement consolidation and drainage works on the side facing Unirii Square. The issue of uneven settlement that has triggered fissures on the main elevation is the result of disperse interventions when refurbishing the basement, i.e. lowering the walking level, as well as of the presence of groundwater on the western side of Unirii Square.

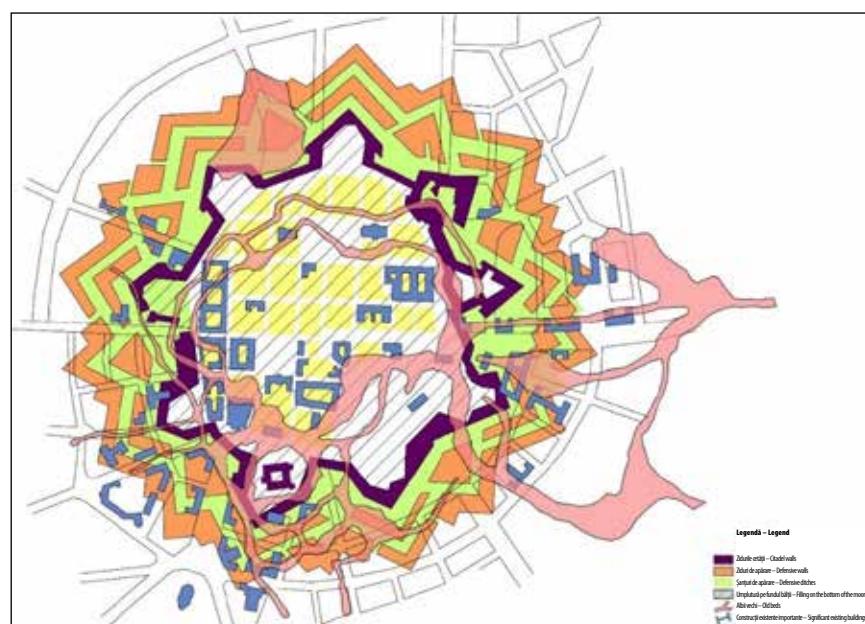
■ **Fig. 1. Harta cu planul cetății fortificate și albiele vechi ale râului Bega** © Bogdan DEMETRESCU
■ **Figure 1. Map with the ground plan of the fortification and the old beds of the Bega River**
© Bogdan DEMETRESCU

■ The works described in the previous chapters deal with several common issues, although they are different in terms of topic, approach, and complexity. The study of the three historical buildings shows that the land is inhomogeneous, as it may present substantial differences in the foundations of the same building. The study of the historical maps and the overlapping with the current situation have pointed out the importance of understanding, as much as possible, the context, its evolution over time, and its relevance at present. The same is revealed by the geotechnical investigations (MARINOV 1997), as they show the routes of the old beds of the Bega River before the construction of the bastion fort in the 18th century, after the Habsburg Empire occupied Timișoara. The old irregular beds that

were crossing the Turkish town before 1716 are currently active in the underground of Unirii Square, and they influence the homogeneity of the foundation ground. This fact and the unjustified interventions on the load-bearing structures, from repurposing basements and lowering walking levels to ground plan alterations for meeting new operation requirements, have triggered a series of issues with major risk in case of an earthquake. Until 1716, the town was organic and adapted to the landscape dominated by the presence of water. After the imperial land planning, massive filling interventions took place. As a result, two subareas can be distinguished today with strong inhomogeneity of the founding conditions.

The first area is the building stock within the old fortifications with 3 to 6 m thick filling above the old beds of Begheiu arms, where the buildings have foundations on wooden piles, which are deteriorated due to the drainage and the low level of the groundwater resulting from the channelisation of the river crossing the town. The second area overlaps with the first ring of the town or with the old circular outline of the defensive walls and ditches, where the buildings are not deteriorated precisely due to the fact that they are more recent, i.e. from the beginning of the 20th century.

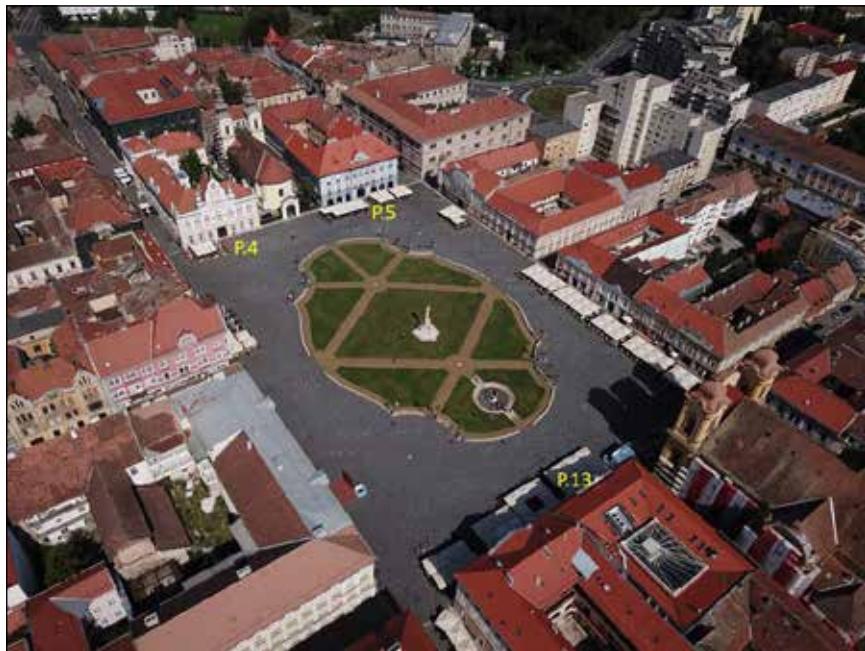
■ **Foto 7.** Vedere de ansamblu cu Piața Unirii și amplasamentul celor trei studii de caz (P.4 – Piața Unirii nr. 4; P.5 – Piața Unirii nr. 5; P.13 – Piața Unirii nr. 13), imagine realizată cu dronă
© Bogdan DEMETRESCU

■ **Photo 7.** Overview of Unirii Square and the sites of the three case studies (P.4 – 4 Unirii Square; P.5 – 5 Unirii Square; P.13 – 13 Unirii Square), photograph taken with a drone
© Bogdan DEMETRESCU
